## Everest Core-Board Revision History

Document Number 108-0141-001

**Everest Core-Board Revision History  
Document Number 108-0141-001**

**Silicon Graphics, Inc.  
Mountain View, California**

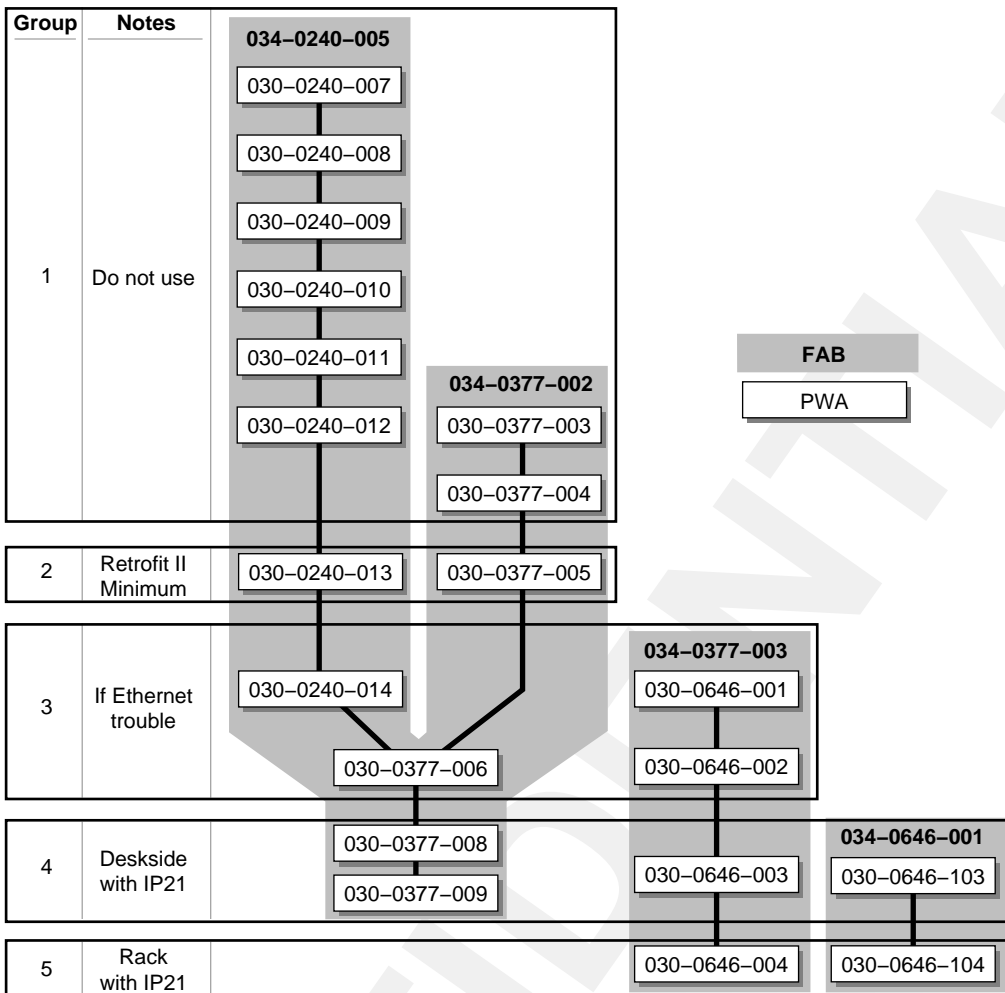
**Figure 4-1** IO4 History Diagram

030-0377-003 and 030-0377-004 have serial-port problems. For this reason, it is recommended that these boards be replaced with 030-0377-005 or later boards.

The first revision of the Flash PROM to support IP21 processor boards was version 3.04. This is found in 030-0377-008 and in 030-0646-x03 and later IO4 boards. Systems containing IP21 processor boards therefore require IO4 boards from Groups 4 or 5.

Rack systems containing IP21 processor boards require the use of either of the IO4 boards listed in Group 5.
